WATERSHED BIOASSESSMENT REPORT

SAND CREEK WATERSHED

Decatur, Jennings, and Bartholomew Counties

2003

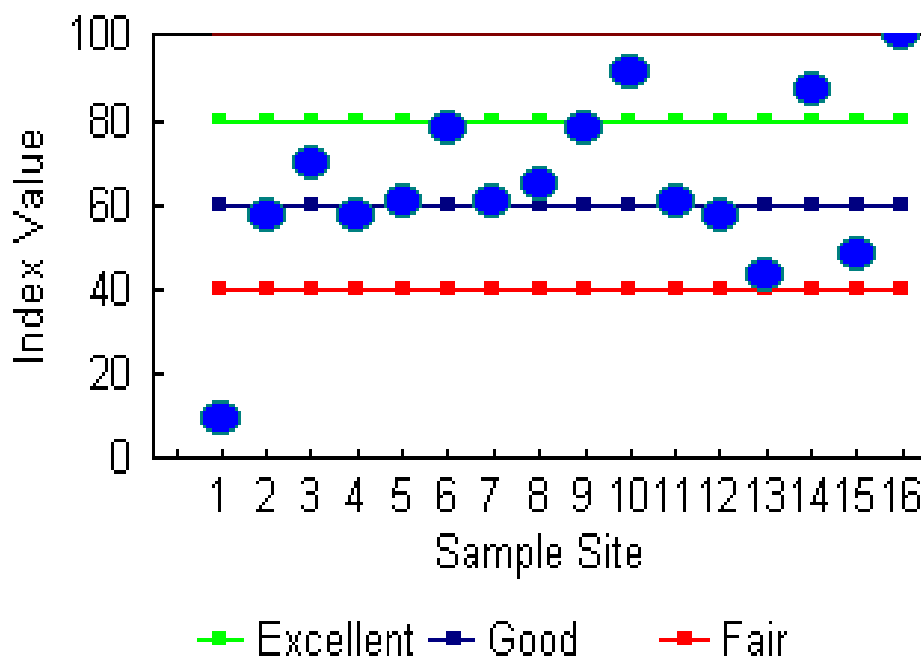
Figure 4

The normalized biotic index scores ranged from 9 to 87. Four sites fell in the “excellent” category, eight sites were “good,” two sites were “fair,” and one site had “poor” biotic integrity.

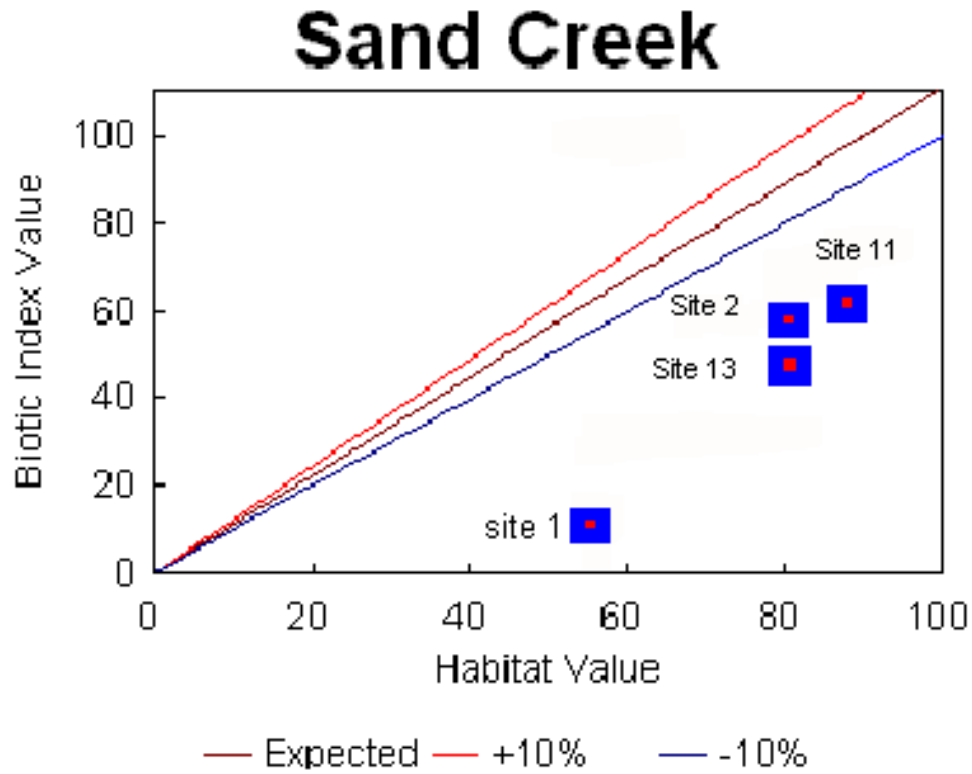
Figure 5

One of the most useful aspects of biological monitoring is the ability to use information on the way aquatic animals respond to different types of stress to diagnose a problem. For example, when aquatic habitat and biotic integrity are graphed in relation to each other, they form a straight line unless water quality is degraded [4]. Plus or minus 10% can be added to the graph to allow for a certain degree of measurement error. When values fall outside this range, water quality problems are suspected. A comparison of biotic integrity to habitat is shown in

Figure 5. This figure suggests that five study sites had degraded water quality. Site 1 (Muddy Fork) deviated most highly from the expected relationship and therefore had the worst water quality. Others with moderately degraded water quality were site 2 (Gas Creek), site 11 (Bear Creek), and site 13 (Nettle Creek).
